# Yarty: River and Floodplain Restoration Feasibility Study

Julian Payne

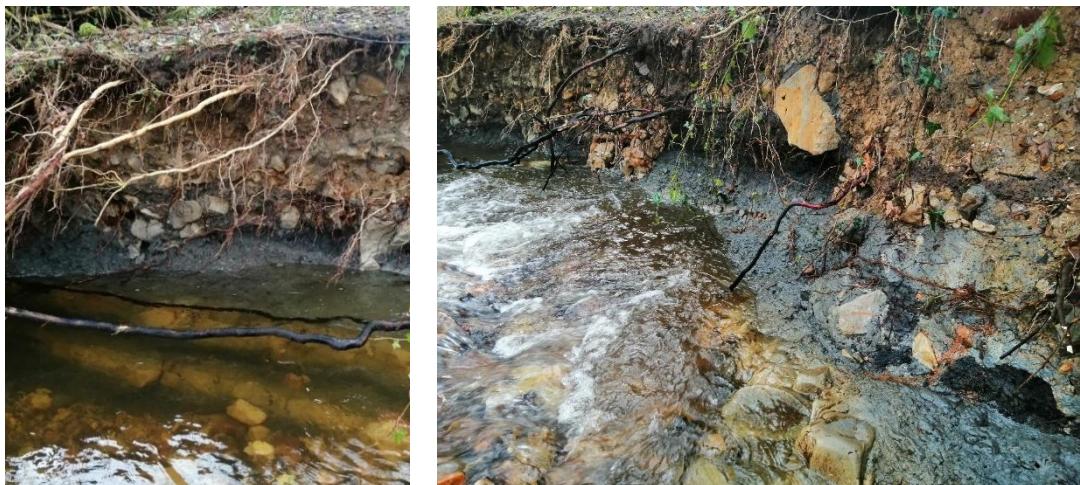
*Figure 3: Complex underlying geology revealed in the eroding river bed*

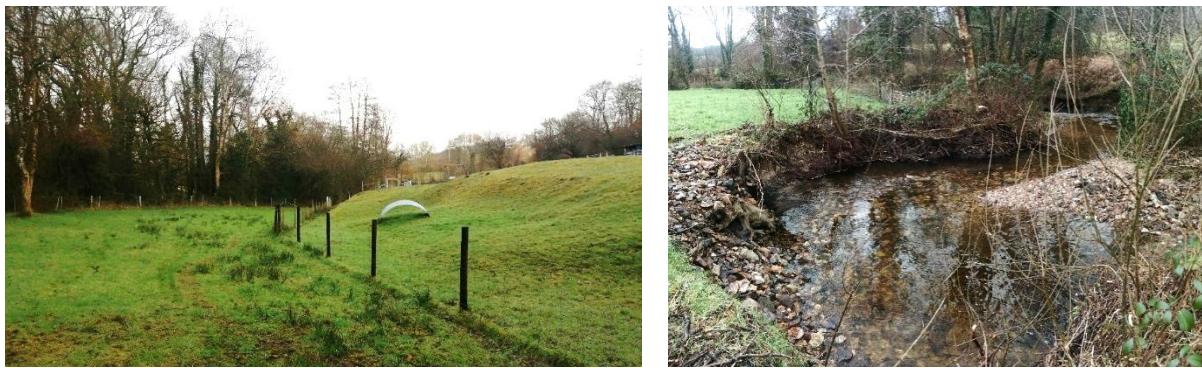
Figure 4: narrow valley floor to plant as woodland, and eroding bend to infill

The narrow valley floor to the east should be planted to establish a dense wet woodland (willow, alder, hazel, black poplar and birch). This is needed to prevent the excess flows that bypass channel from cutting a new route. Dead wood should be installed across the width of the valley floor to slow flows whilst the woodland is becoming established.

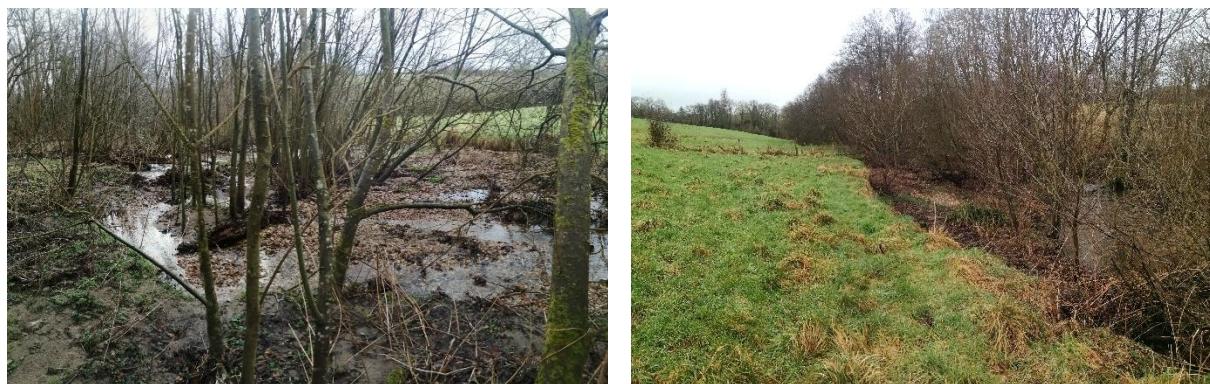
*Figure 5: Developing wet woodland, set lower than valley floor which might be lowered*

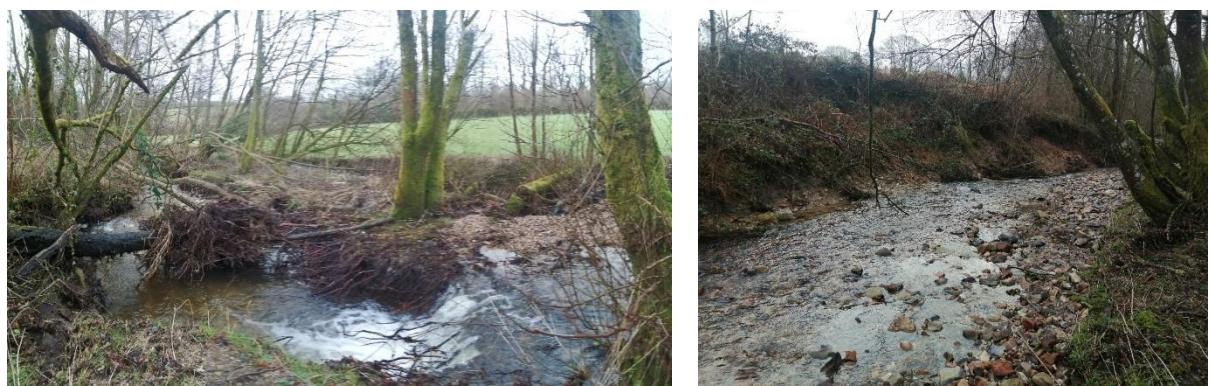
*Figure 6: Example knickpoint and hillslope erosion where live willow staked brushwood may manage*

A further immediate measure would be to pack the front of the eroding hillslope with a dense mattress of brash or brushwood. Again, staked with live willow.

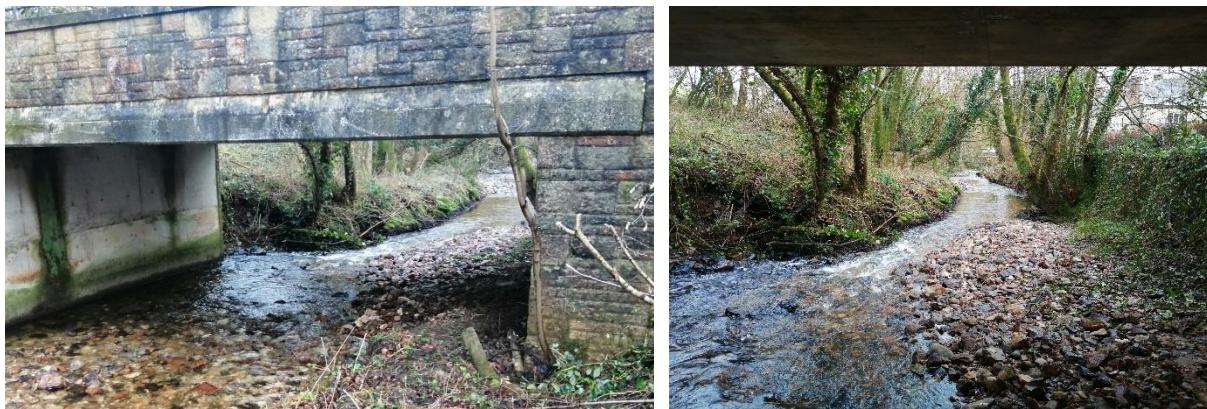
Figure 7: left hand side berm might be removed, and the bed reinforced with large stone size mix

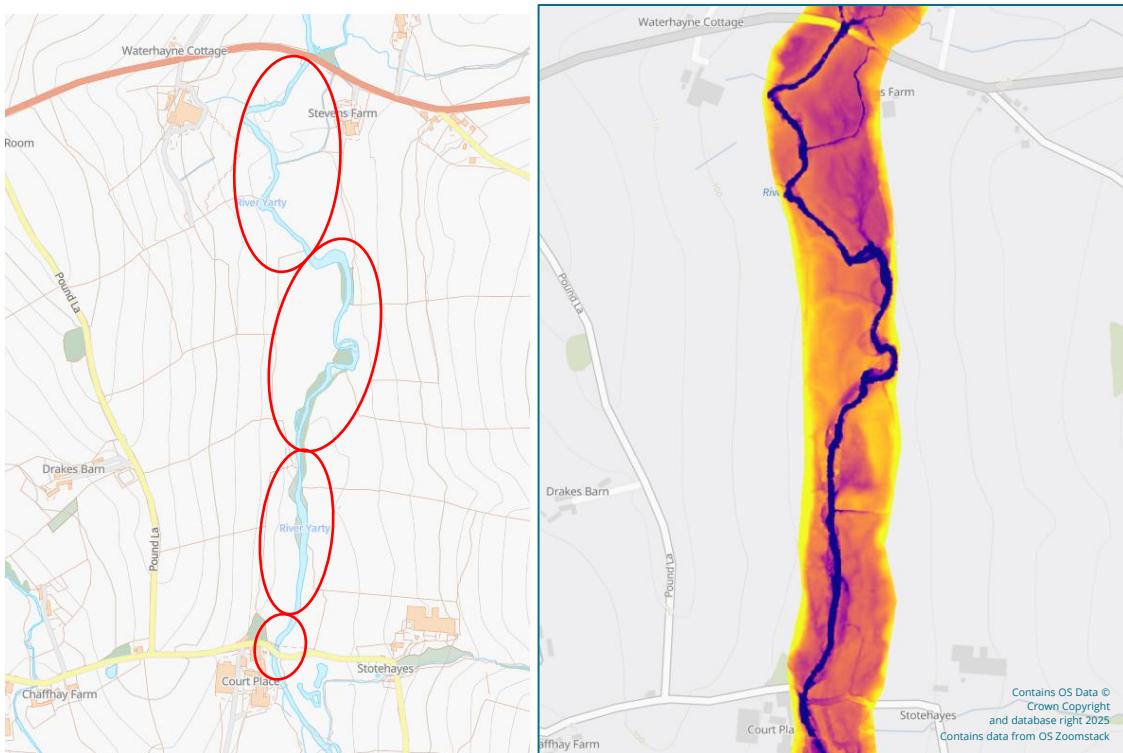
Figure 8: Areas of four changes in river character, with a heat map of valley floor drainage features

For 300m south of the A30, the river follows a well-defined treelined route, with gently sloping valley sides extending to the narrow river corridor. However, as it meanders over to the east of the valley, it cuts deep, with a wide channel abutting the higher ground beyond. The persistence of the instability here is evident in the exposed and broken pipeline at the apex of the bend.

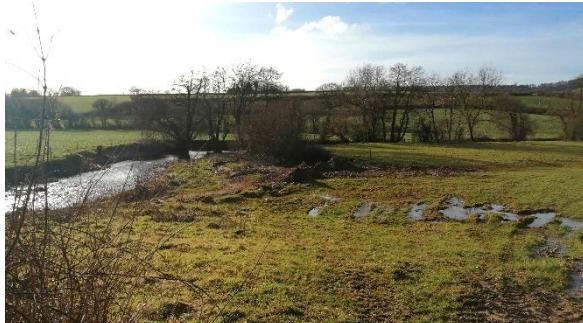
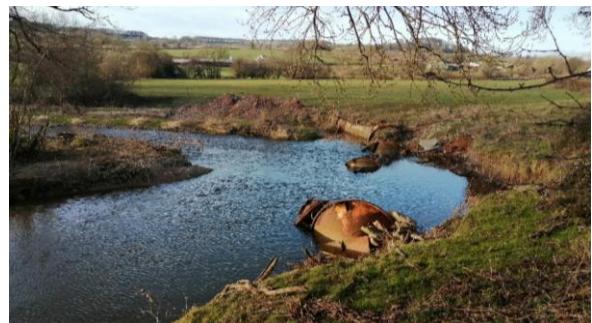
*Figure 9: the upstream treelined stable channel, and start of the bed incision and instability*

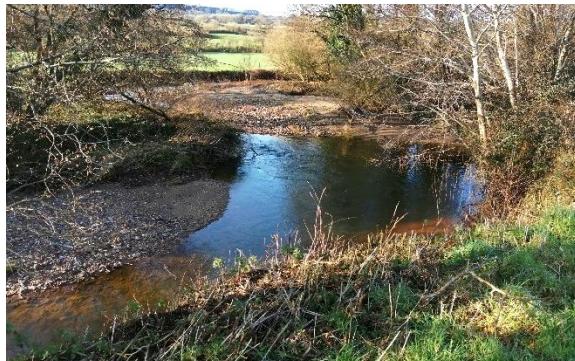
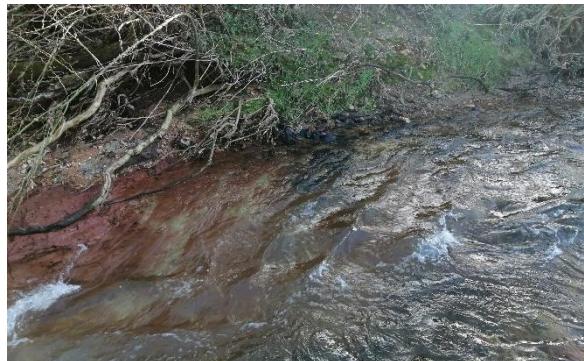
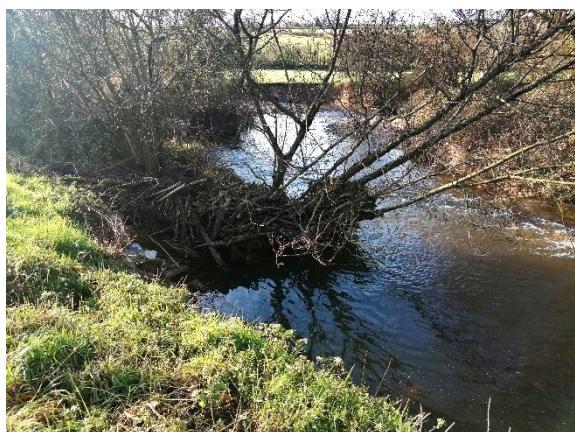
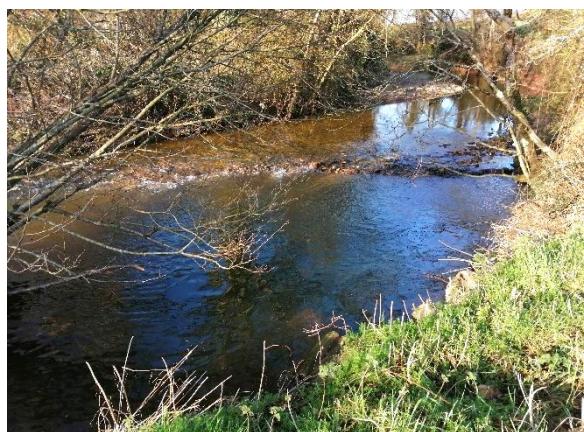
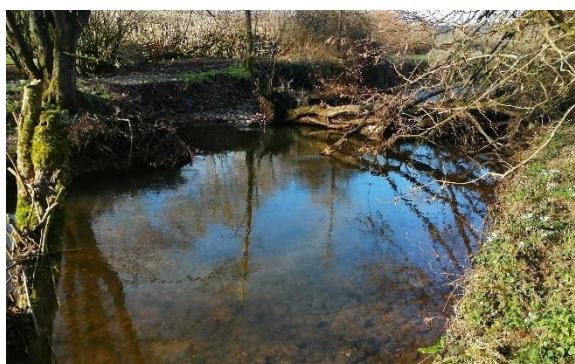
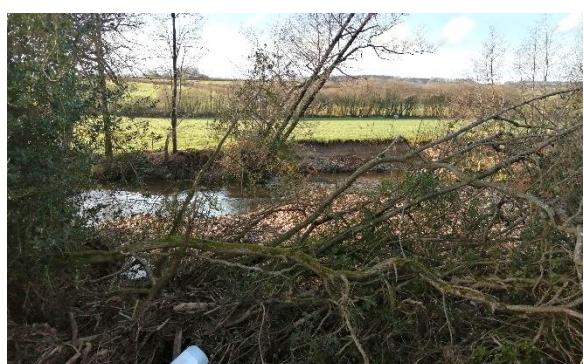
For the next 400m or so, the river cuts a deep swathe through the constrained river corridor. Within this corridor the channel frequently shifts its route. All stable cobble and gravel beds have been lost, with the river cutting into the underlying clays. Deep waters are impounded by temporary accumulations of gravel and cobbles, with heavily silted conditions in between.

*Figure 10: Deep incision and instability in the constrained central river corridor*

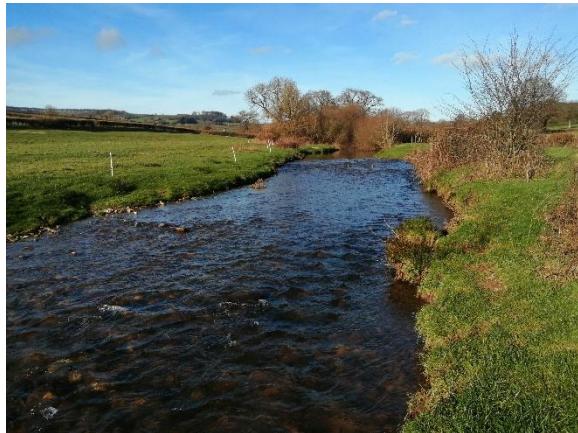
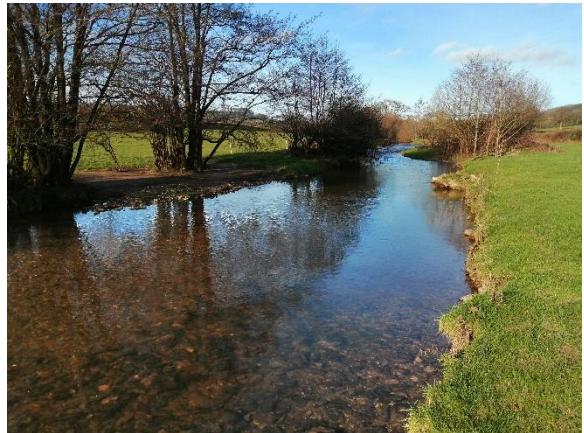
For much of the lower section, the river flows in a shallow channel, with low lying land on both sides. There is a lack of riparian vegetation with past grazing pressure. Midway there is a run of fairly stable gravels and cobbles, which for some reason lack any floating vegetation. This may be linked to the heavy levels of siltation through much of this section, and indications of nutrient loading.

*Figure 11: the lower reach is more stable, with shallow channel and stable gravels, but lack of floating vegetation, silt and algae suggest possible nutrient and past grazing and packing pressure.*

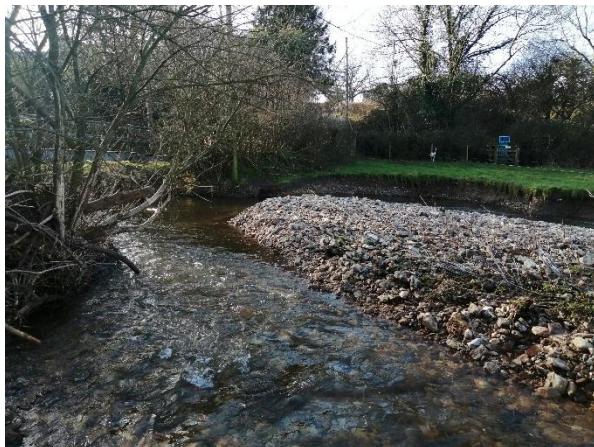
As the river heads towards the footbridge and ford, it is constrained by the hedge line and driven by the gradient over the ford. The energy resulting from this combination has recently reactivated the channel, such that the footbridge has become undermined, and the flood warning gauge is threatened. Without the ford in place, the erosion and instability would be significantly worse and would be expected to migrate upstream.

*Figure 12: The constriction of the hedge bank and drop off at the ford is triggering instability immediately upstream resulting in the undermining of the footbridge.*

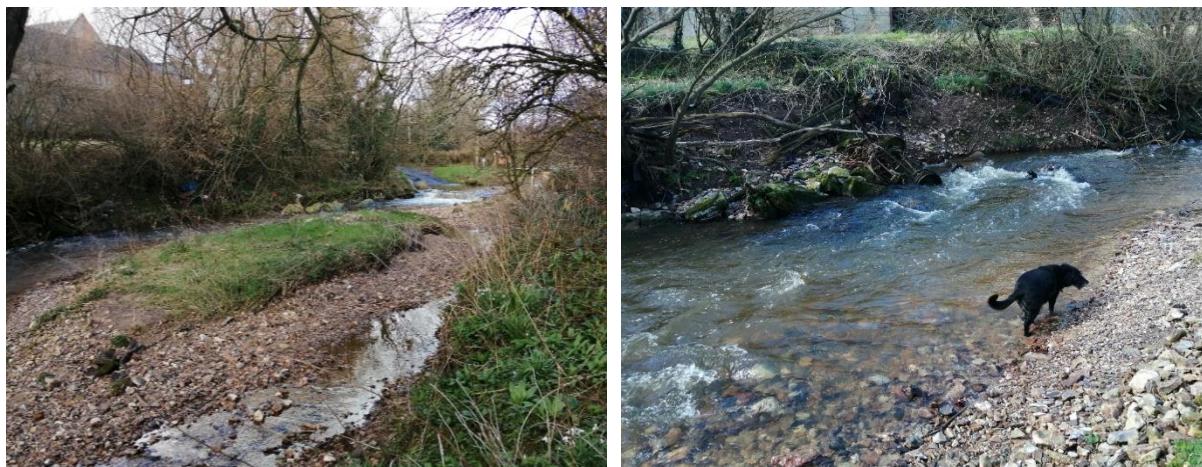
For the initial northern section, consideration should be given to the ford crossing and whether it should be modified or replaced. In higher flows, with the pipes blocked, there appears to be some fish passage on the western side. However, in lower flow conditions, and potentially with the pipes free flowing, fish passage will be more restricted. As noted in the report section above, however, the presence of the ford does at least prevent bed incision from migrating upstream.

*Figure 14: Flows pass over the pipe ford, with flows and bed incision concentrated on the western side*

Raising and protecting bed levels at the downstream of the length of river should be the starting point of consideration. This might be to import a loose array of boulders, around 500mm in diameter for the downstream 50m. As a loose array, and ideally set slightly into the bed, they should start to trap and accrete gravels and cobbles that are washed in from upstream. This will then naturally raise the bed in normal flow conditions whilst resisting incision in flood conditions.

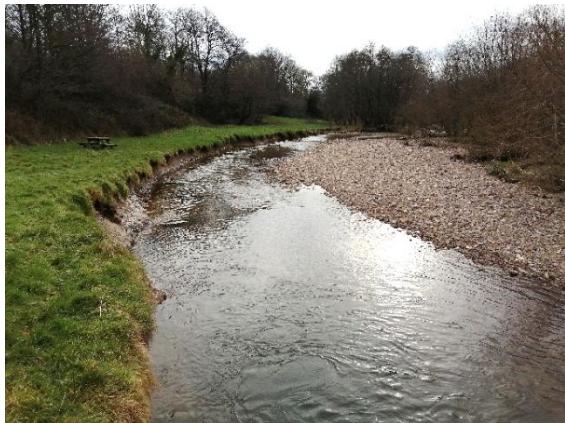
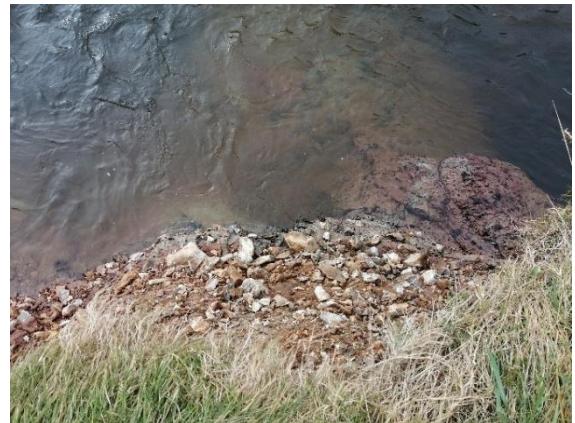
*Figure 15: Upstream left bank erosion; the banks are formed of terrace fill above underlying clay geology layer*

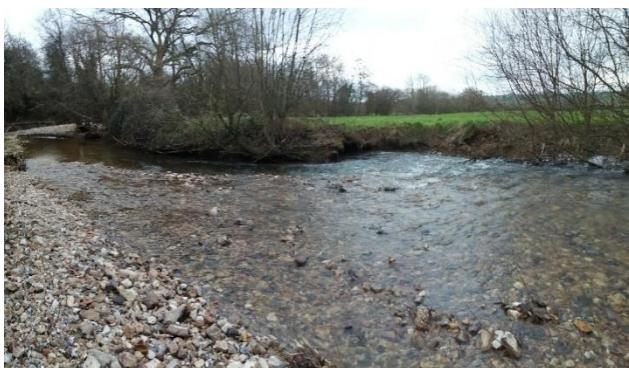
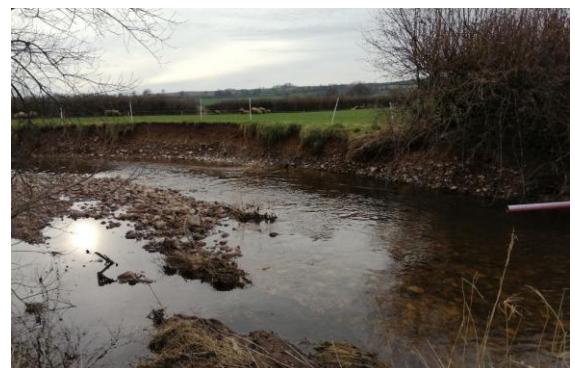
*Figure 16: Upstream right bank pocket erosion, will develop quickly into the field; downstream eroding bend – extent of erosion demonstrated by the exposed land drain to the right of the photo.*

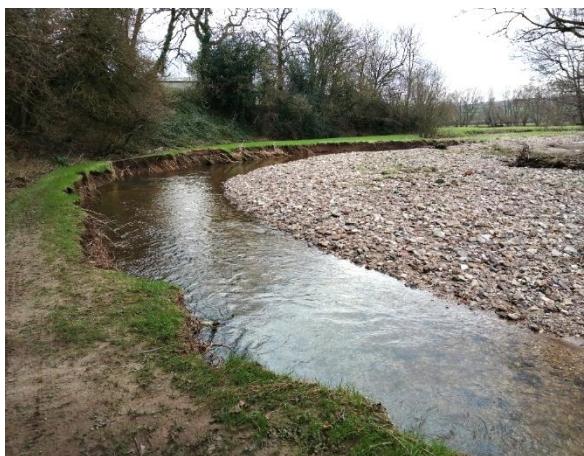
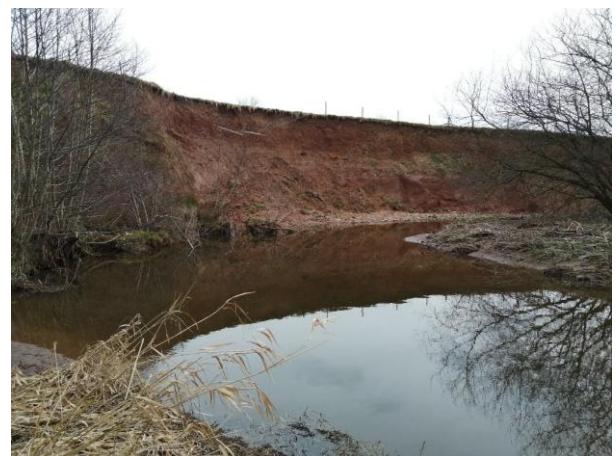
*Figure 17: Middle left bank erosion threatening access; and the eroding cliff downstream*

The cliff has two failure mechanisms occurring. Along the toe of the cliff the erodible clay geology is being cut into by the river, taking away the foundation of the cliff. The upper part of the cliff is terrace deposits. The terrace deposit's collapse is driven by both the undermining of the toe, but also seepage and hydrostatic pressures from the hillslope above. This feasibility study can only consider management of the river's erosion of the toe. Further geotechnical advice is required to manage the stability of the upper part.

Solutions such as a willow spiling hedge bank, a mass stone, or a rip-rap (a stone mix) revetment may be feasible. As noted, it is important that these extend along the full length of at-risk bank line. They may be constructed into the existing channel, however, careful consideration of the alignment of this is needed to avoid increasing bed erosion.

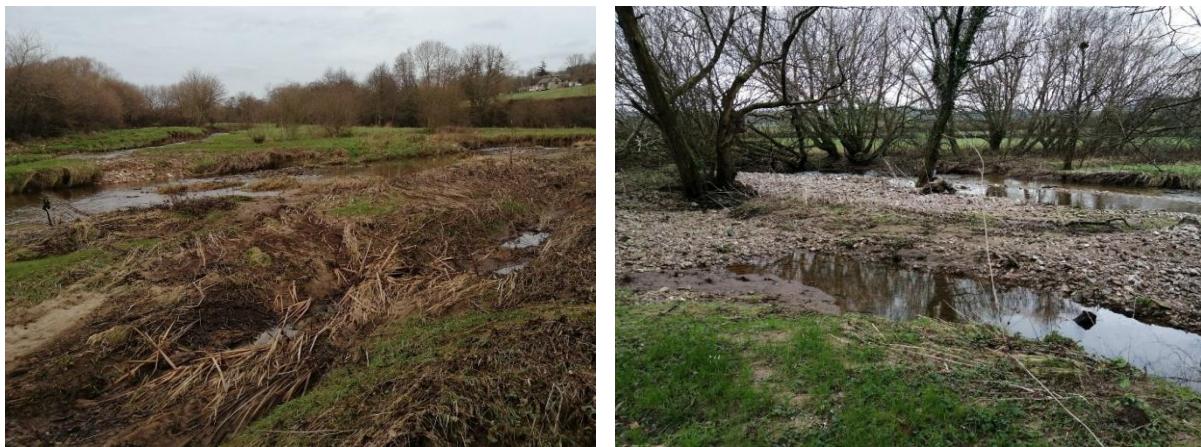
Figure 18: Dynamic wet valley bottom habitats.

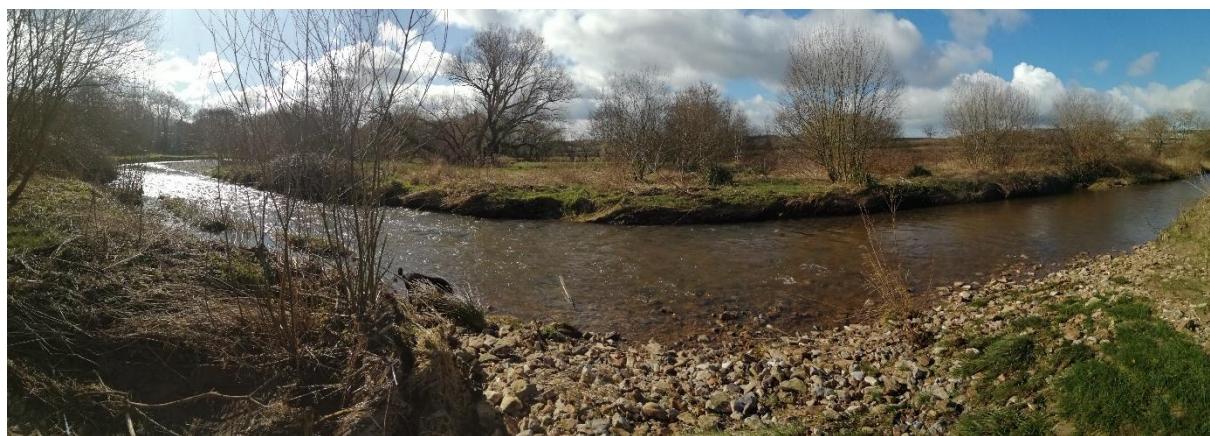
*Figure 19: View from east (left bank) at Stotehayes where the valley wide reset should begin*

The valley wide reset should ideally start within the Stotehayes curtilage - from where the channel first switches from the west to the east of the valley floor (around ST 2561 0679). It should extend down through the length of Lugg's Farm. Consideration needs to be made in the design for the transition to Bowditch Farm downstream.

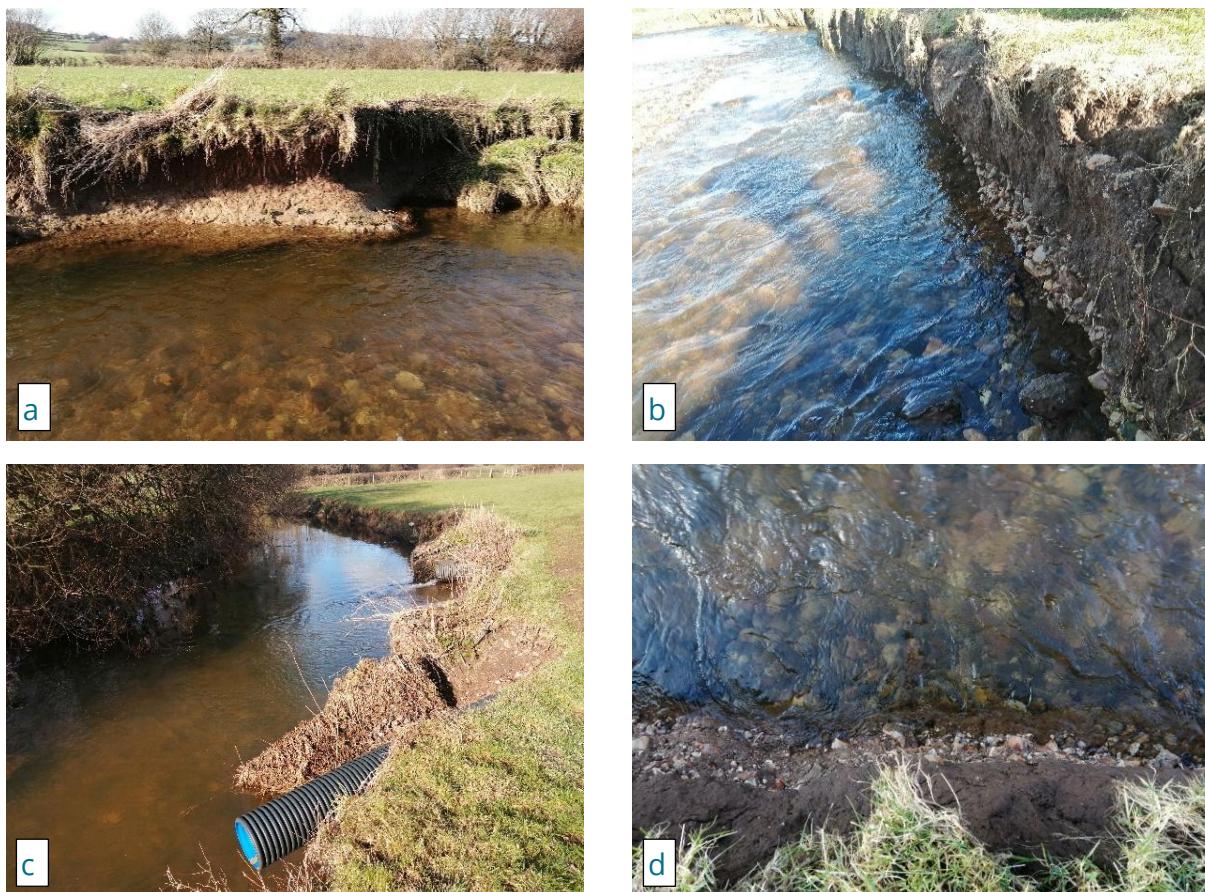
Around 150m downstream of the boundary with Lugg's farm, however, there is a shallow section, where there has been limited incision below the gravel strata in the bank (Figure 20b). This provides reference conditions for restoration. Upstream, of this, the incised channel is impounded by this shallow section, resulting in silted conditions during lower flows (Figure 20a).

Figure 20: Bed incision a) upstream 150m with silted bed, b) limited shallow incision below first meander, c) undermining former gabion bank protection, d) incision dropping below gravel strata

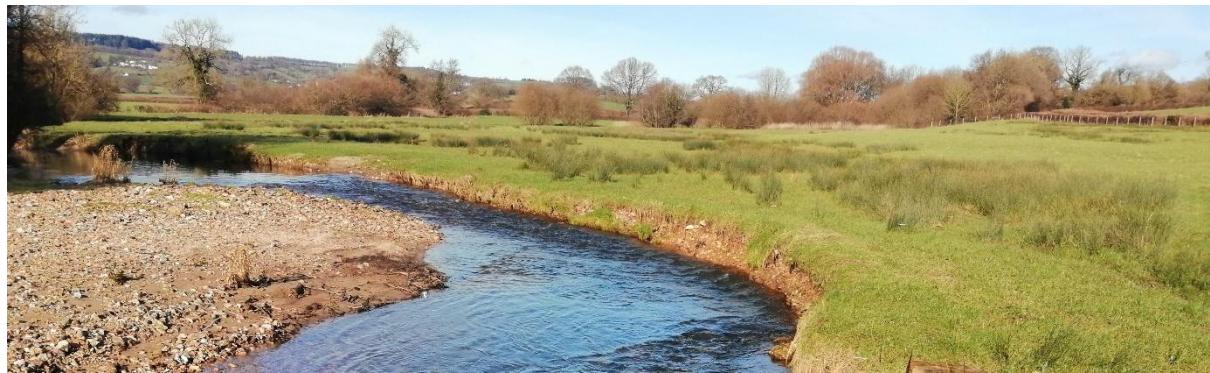
Figure 21: The upstream meander, with shallow bed and wetland in former channel route

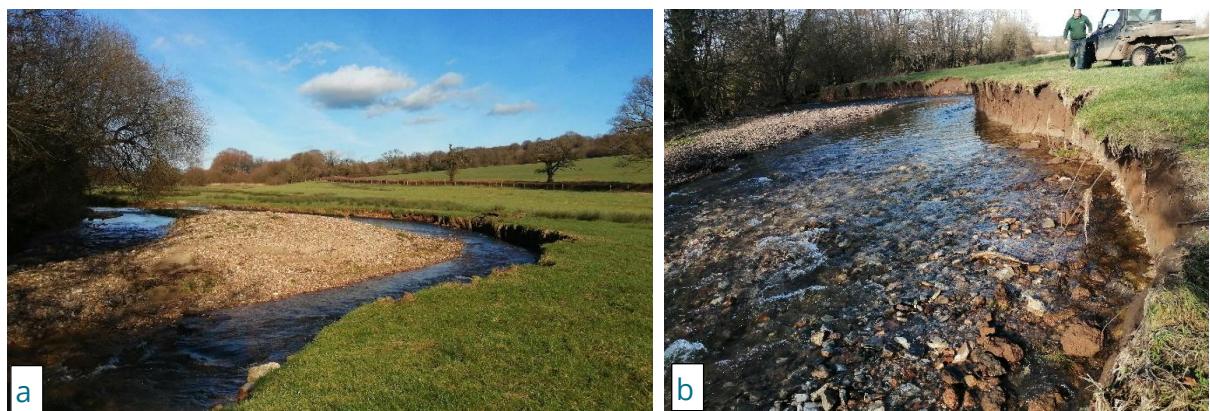
Figure 22: a) Reworking of the meander is exposing past bank protection, b) fresh and accelerating channel migration is driven by bed lowering downstream

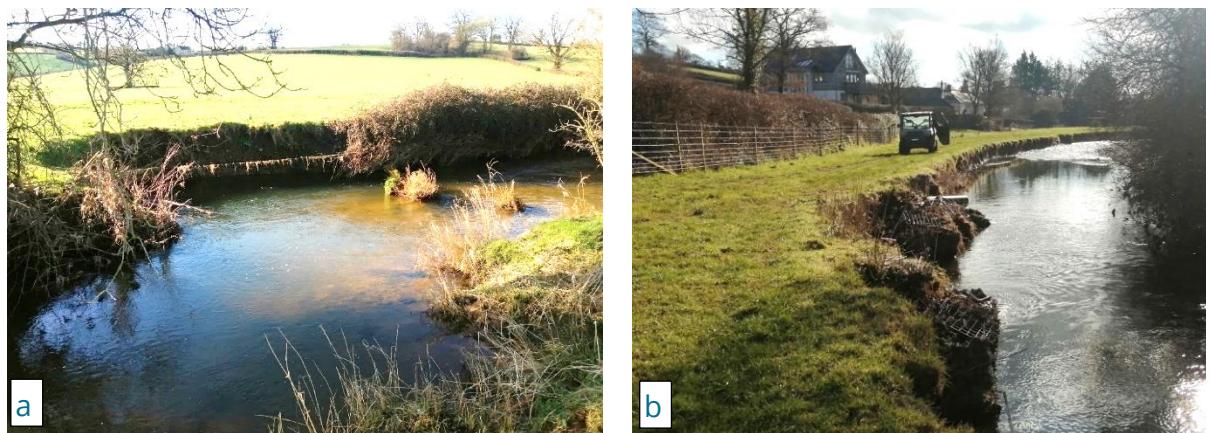
Figure 23: a) Erosion starting on right bank in response to lowering bed levels downstream, b) erosion to the left downstream exposing and undermining old bank protection.

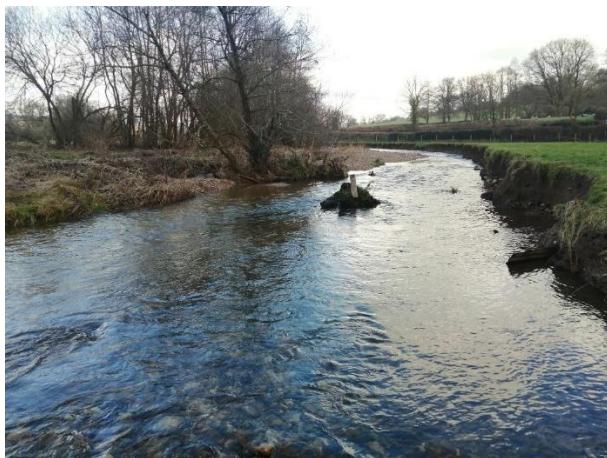
*Figure 24: Past and continuing channel migration upstream of Long Bridge*

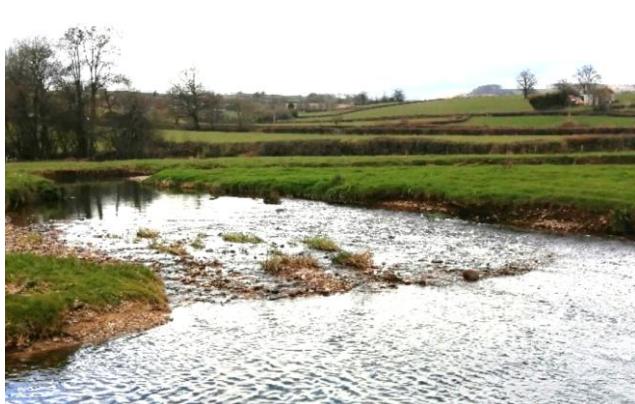
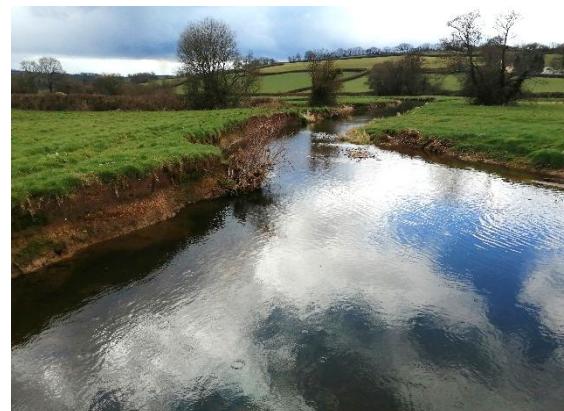
The cut through of the former meander bend increased the river gradient and so increased the velocities and erosion along this reach. The section then being impounded in low flows by the riffle at the downstream which retains the more natural bed level.

Figure 26: Natural shallow depths at the downstream riffle, impounded deep incised section upstream

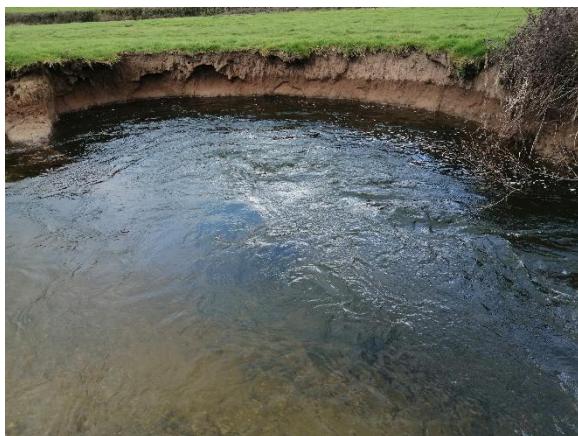
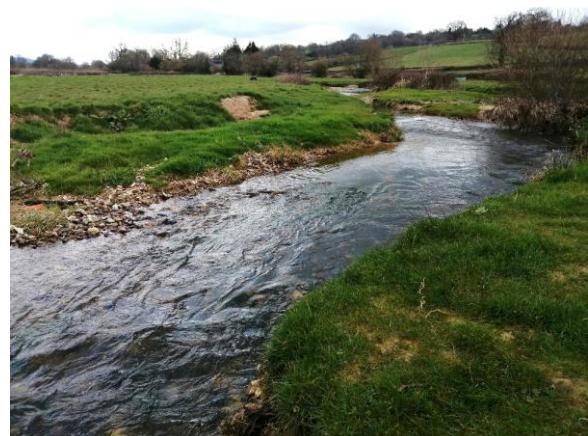
*Figure 27: Example of deep scour hole downstream of riffle with floating vegetation, this scour hole needs to be filled, and the bed reinforced to protect the riffle habitat*

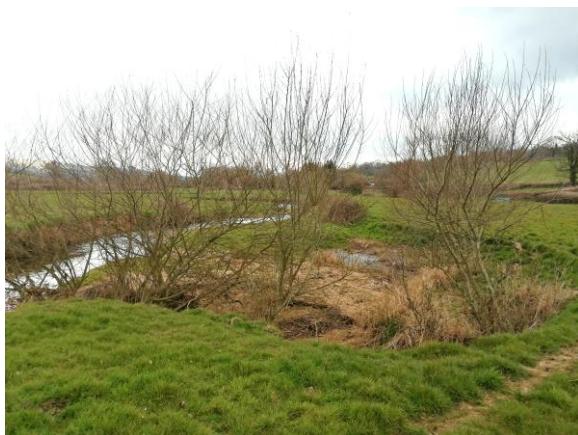
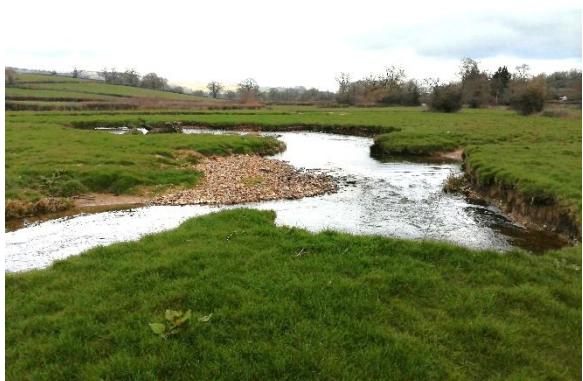
There is a small meander bend which may have either broken or been cut through. Gravel extraction may also have been carried out. Cattle poaching of the bed is also evident with the lack of fencing. All of these will have increased pressure the bed and channel stability.

*Figure 28: The small cut through meander and further example of deep bed scour threatening further land loss*

Consideration might be given to either infilling the cut through of the small meander, or planting or driving in live willows stakes or alders across the channel to encourage the river back to the former meander route.

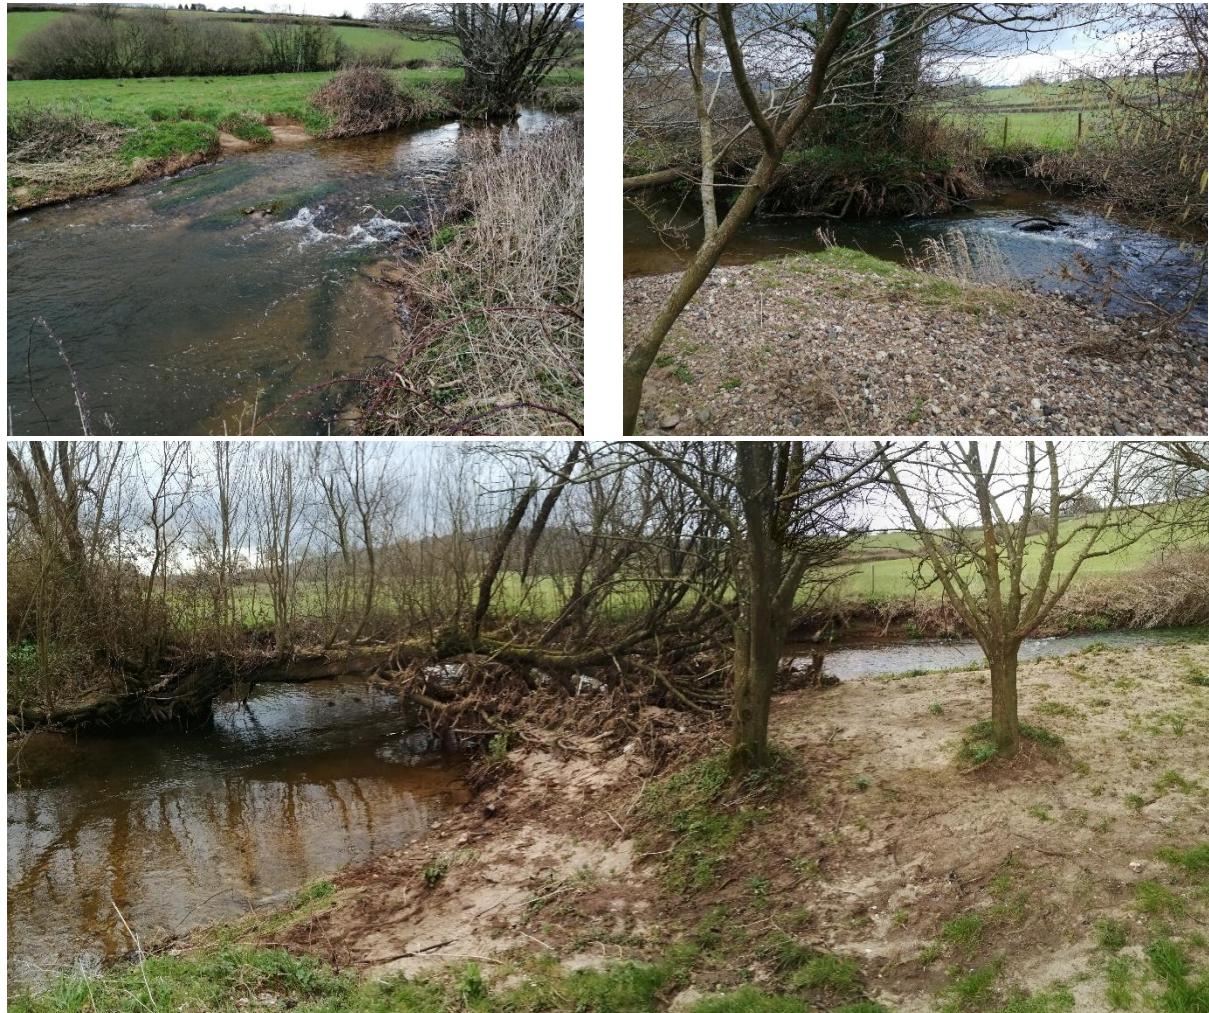
*Figure 29: Ranunculus beds are retained in stable cobbles, but under pressure from cattle access, increasing vegetation complexity is slowing but not removing erosion pressures*

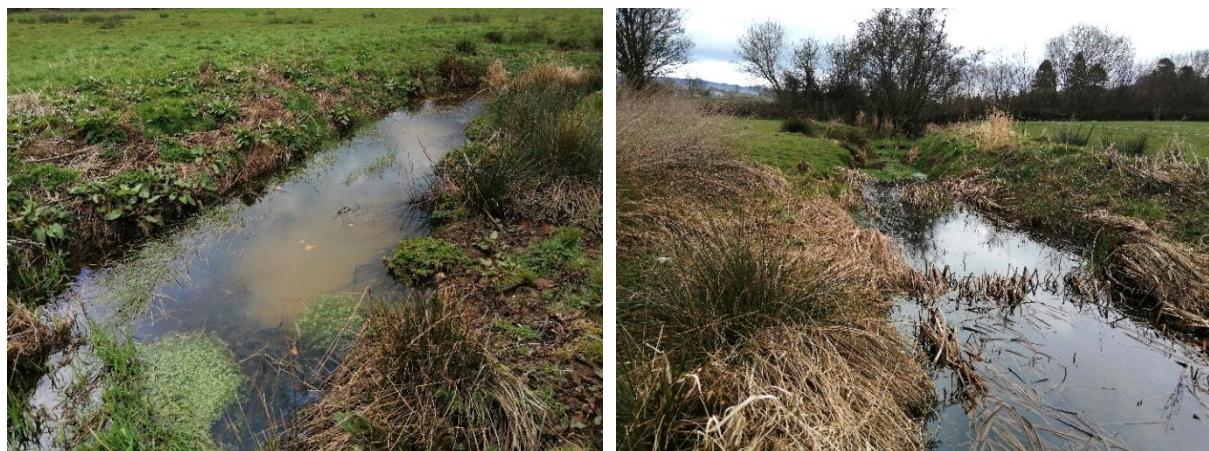
*Figure 30: Former wet meadow channels provide valuable refuge habitats in the place of natural backwater features.*

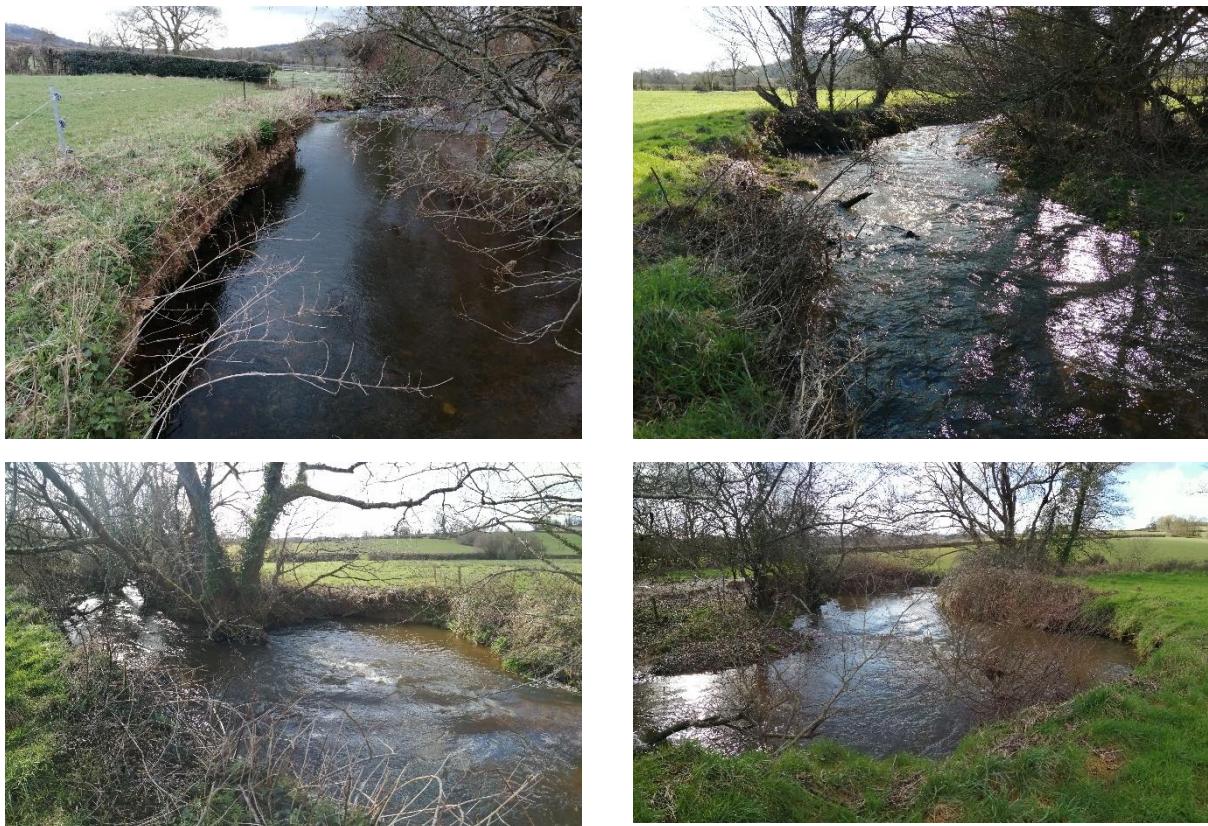
*Figure 31: Channel incision is beginning to threaten banks that have previously been protected by riparian trees, rapid bank erosion is liable to follow.*

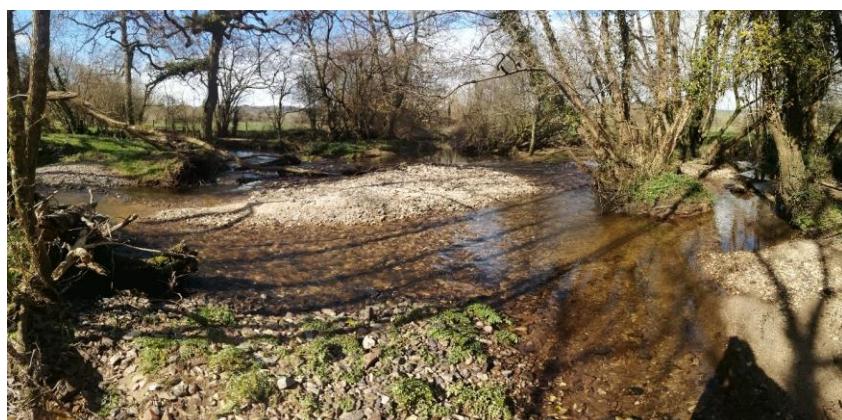
A small woodland (at around ST 256 0413) extends along some 60m of the river corridor. The woodland is not sufficiently dense or well developed to entirely achieve a dynamic equilibrium. However, it does demonstrate the range of habitat conditions that are possible within this part of the river system and how these can counter channel incision.

Figure 32: A rare example of anastomosed channels within developing wet woodland

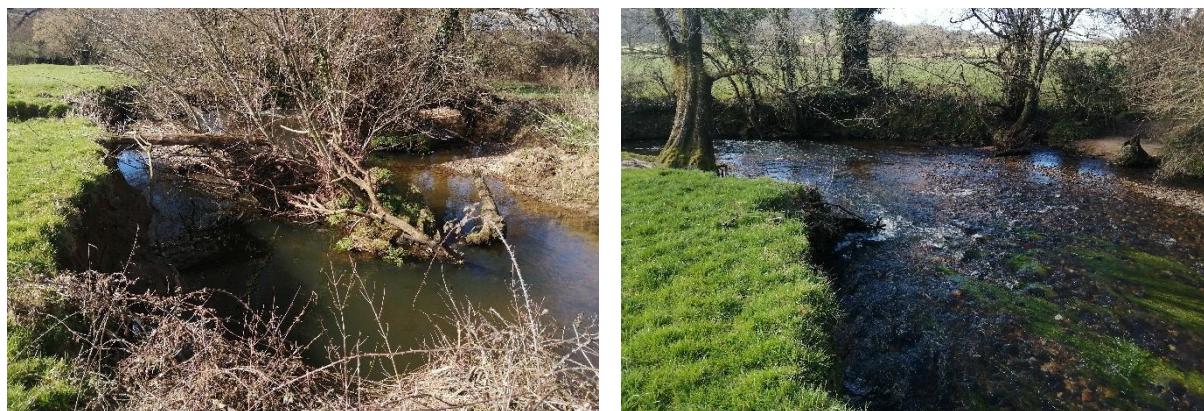
Where the bed erosion and bank failure has cuts beyond the riparian treeline, the river has rapidly cut a wider channel whilst retaining the depth.

*Figure 33: Channel incision eroding beyond the treeline (left), and from downstream threatening the stable cobbles and ranunculus upstream (right)*

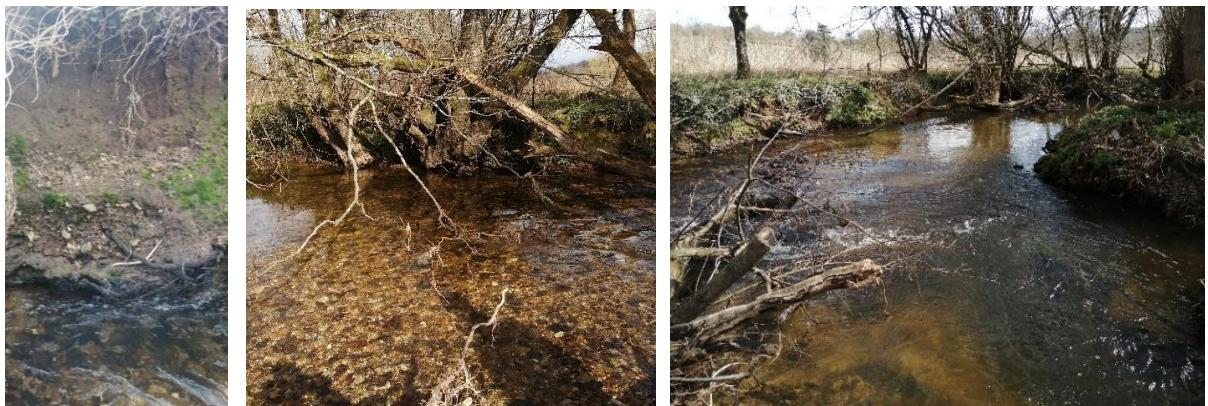
*Figure 35: a rare example of dark organic rich layer of the former valley floor wetland survives, the bed nearby remains close to the original levels, but downstream incision has occurred*

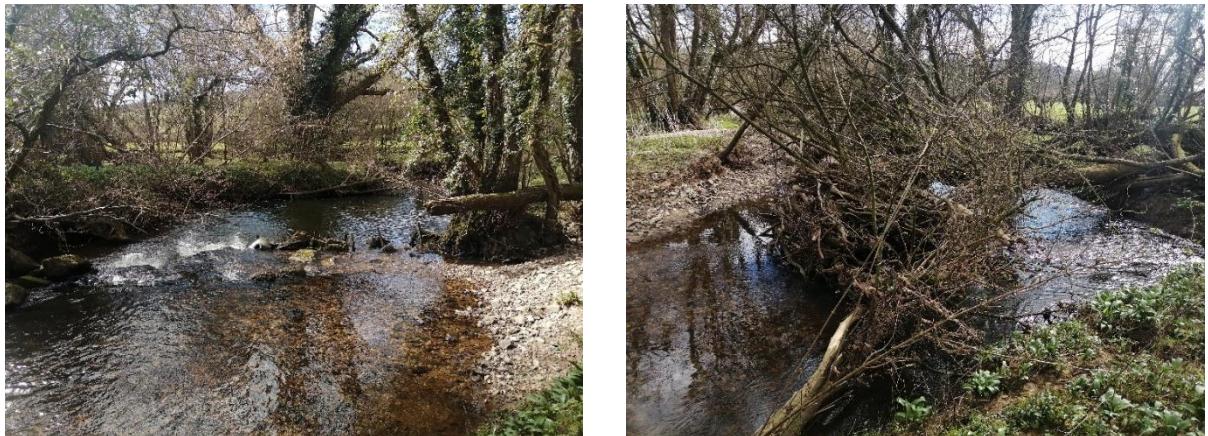
The duration of the change is evident from past attempts at resisting the erosion processes. These interventions are now failing, in part due to their localised nature. IN other locations tree jams and tree stands are slowing the rate of change, but the density of these is not sufficient to counter it.

*Figure 36: former bed and bank protection measures are failing as they are undermined, even large tree jams are unable on their own to stop the erosion processes entirely*

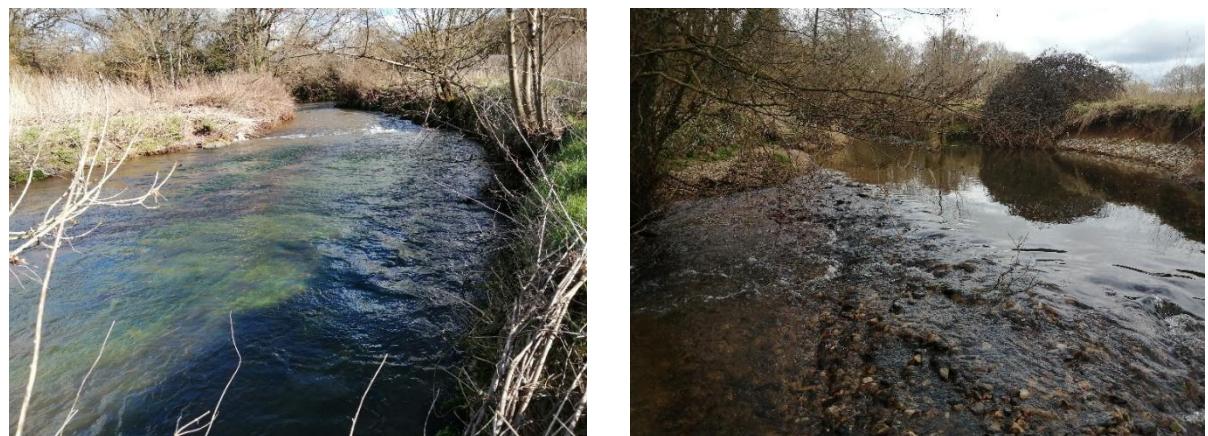
The most resilient and abundant ranunculus bed is in the 20m or so upstream of the weir at Case Bridge. This artificial bed control is providing stability that was once likely present throughout the river. This allows the vegetation and the ecology to thrive. However, within only 20m upstream, the bed is eroding. A similar distance upstream again, a section of former river bed is now collapsing and a deep incision in the bed is leading to bank erosion upstream. This demonstrates influence of gradient and energy on the system and the need to work over large distances to be effective.

*Figure 37: A vibrant river bed community is sustained by the weir at Case Bridge, but within 50m the river bed is cutting through former river bed levels and eroding the bank*

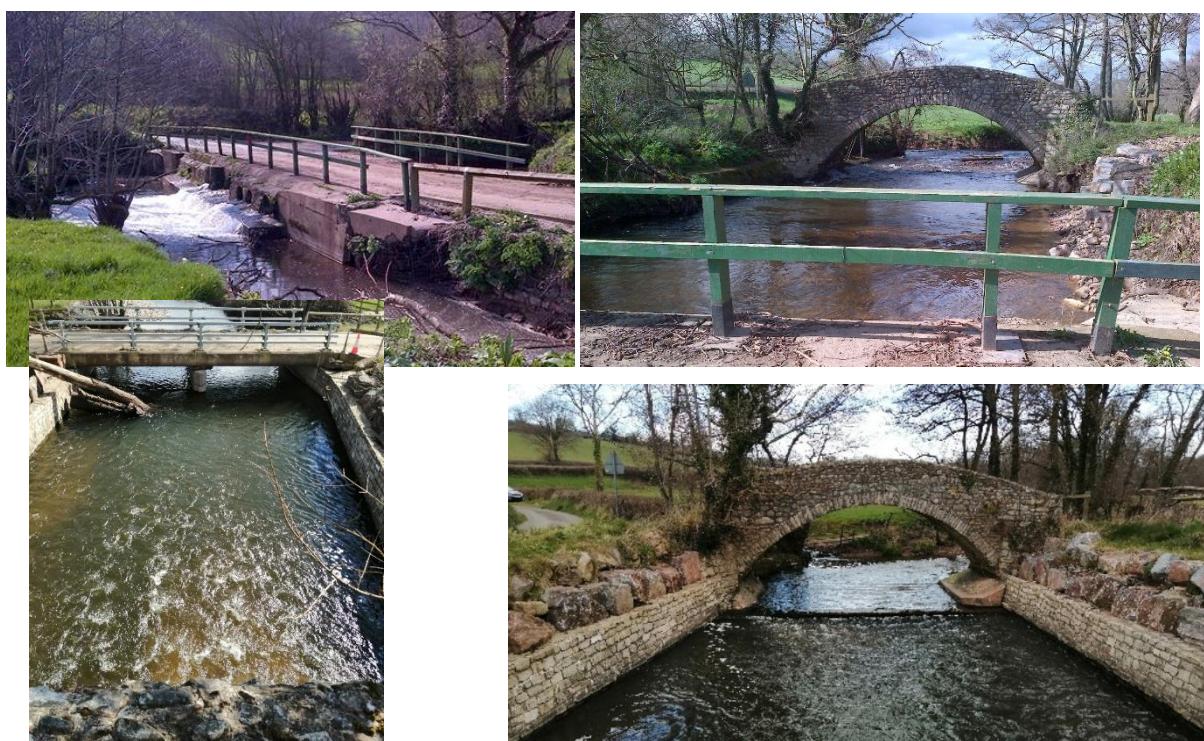
The flume effect of the bridge and removal of the downstream bed control has, however, resulted in deep scouring of the river bed downstream. The invert may present a barrier to fish in low flows. However, especially with the deep holding pool downstream, it shouldn't present significant issues in higher conditions, that is until flood flows result in excessive velocities.

Figure 40: Alterations at Beckford Bridge affecting bed levels and fish passage

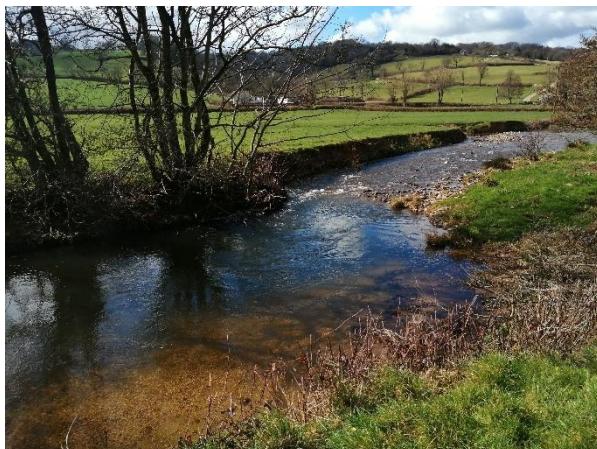
Figure 41: Bed incision is still migrating upstream and threatening shallow channel sections.
