# Yarty: River and Floodplain Restoration Feasibility Study

Julian Payne

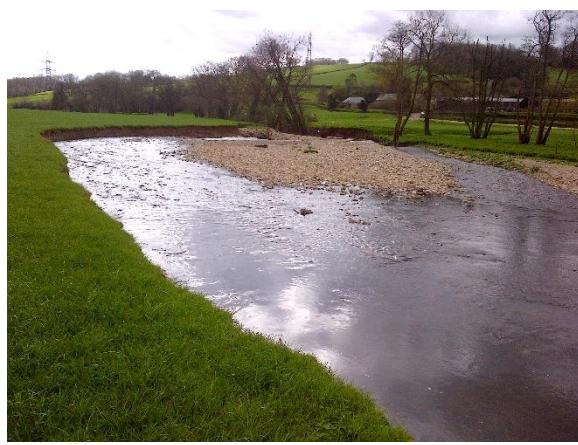
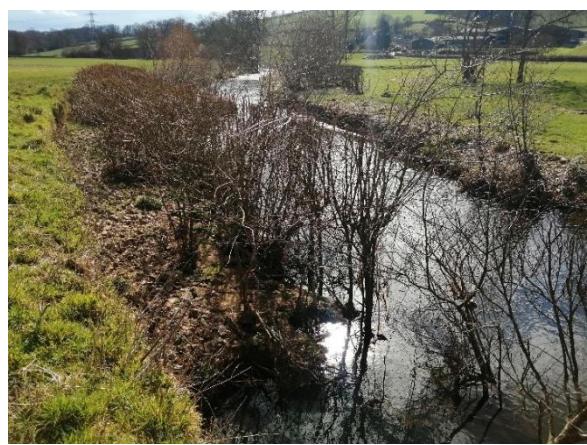
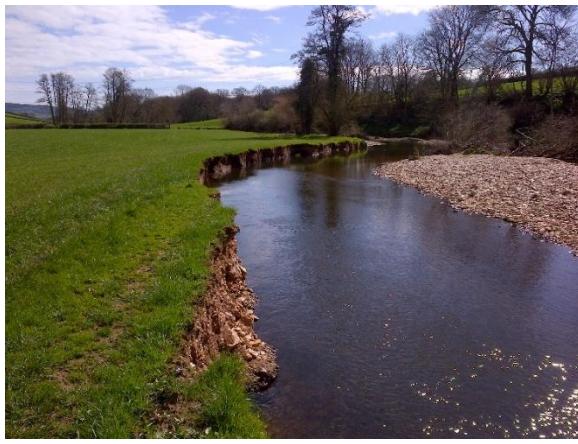
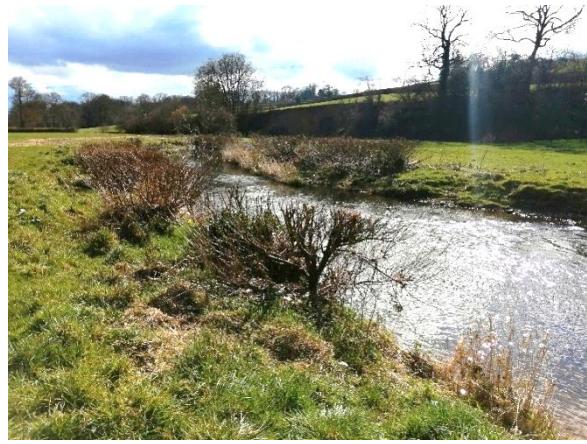
Large live wood interventions have been carried out which have reduced lateral erosion and even created accretion and restoration of floodplain. These do not control the bed levels though. Further live wood introduction but combined with an array of boulders across the channel in deeper sections and downstream of knickpoints would be beneficial.

Figure 42: Massive lateral movement in 2014 controlled to some extent by live wood introduction.

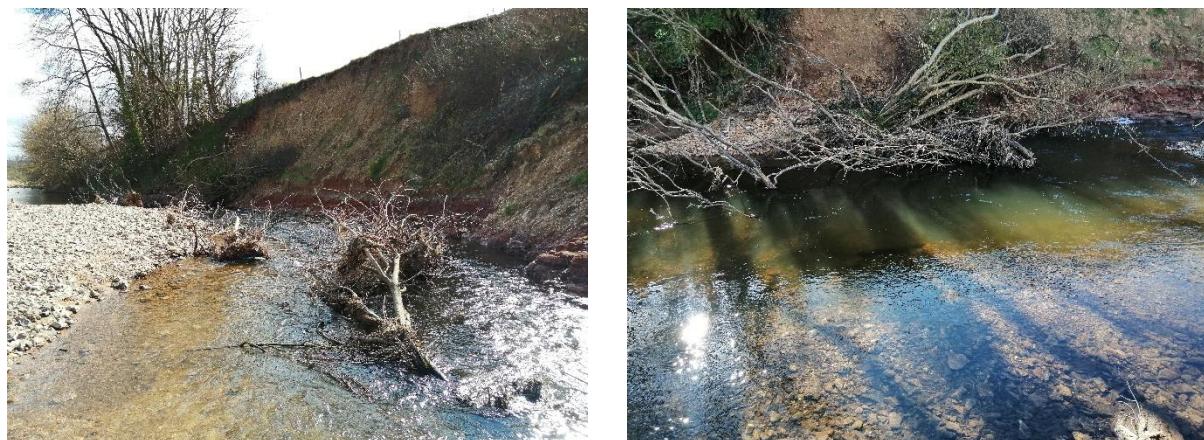
*Figure 43: Bed incision and toe erosion along the hillslope, leading to mass failure*

Some raising of the bed levels downstream with over-sized stone mic would also be valuable, especially in the deeper part of the channel abutting the hillslope.

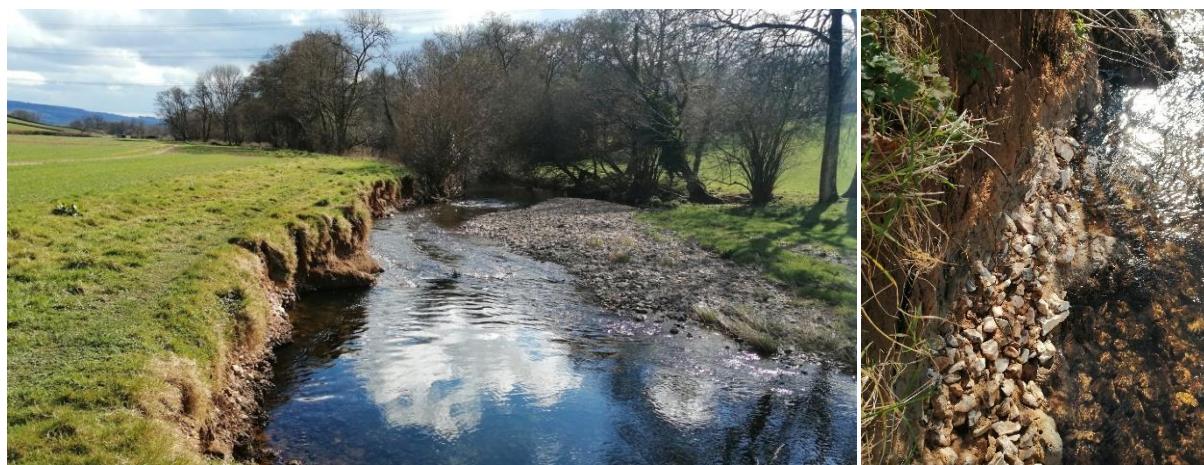
The LiDAR levels do suggest a history of channel movement in the western strip of the valley floor, and a channel on the very far eastern side of the valley. South of the power lines, there are signs of drainage in the east and centre of the floodplain, draining this area. There is also a well-defined backchannel joining from the eastern edge of the valley at Yeatlands Farm. This does in combination suggest that wet meadows may have been operated on the eastern side of the valley, with works to control the river away from this, and resulting accumulation of sediment raising levels. This combination may well be linked to bed incision, which has then migrated north impacting the land there as described above.

*Figure 44: The eastern floodplain is elevated above the west, triggering bed incision*

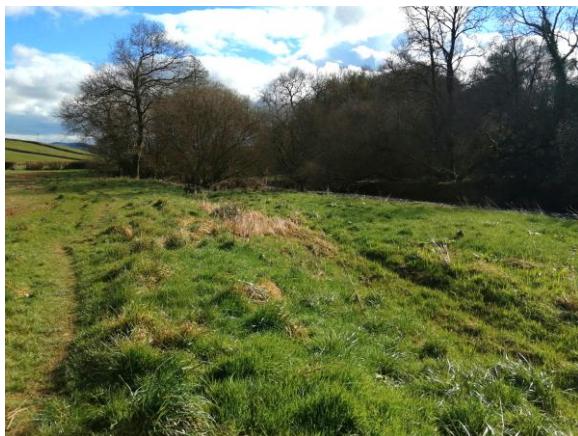
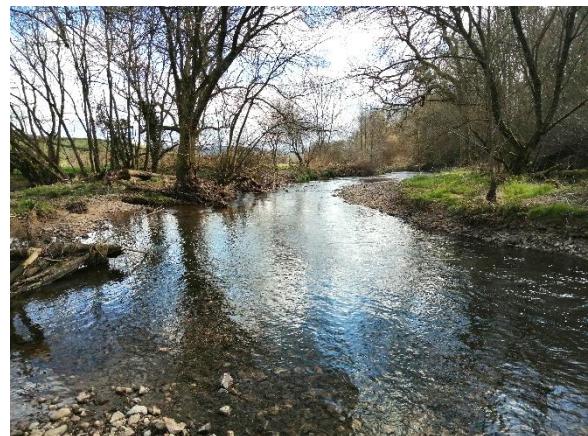
*Figure 45: A lower river corridor to the west where channel movement has occurred, vegetation is provide some control on this*

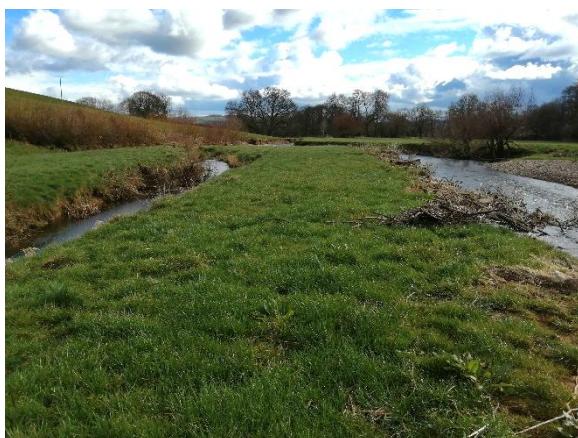
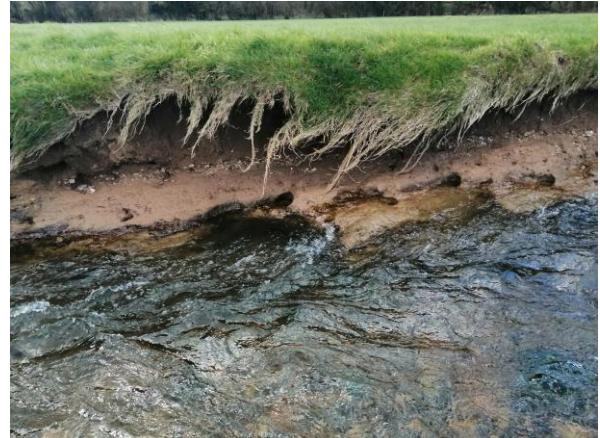
*Figure 46: Probable former water meadow outlet joing the riev, where the main channel is incising into underlying clays*

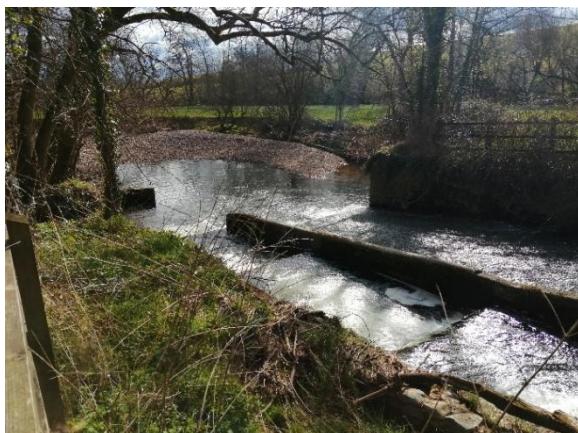
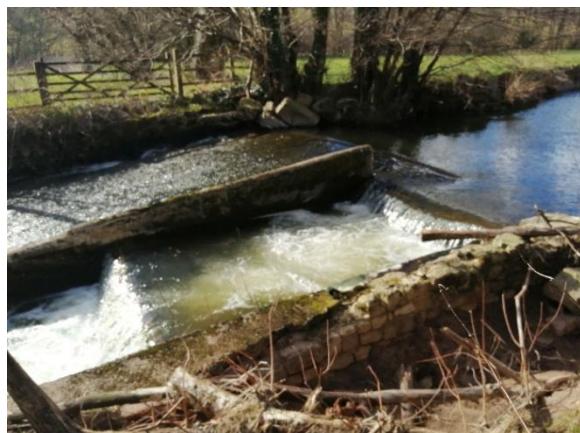
*Figure 47: Higher Westwater Weir and fish pass*

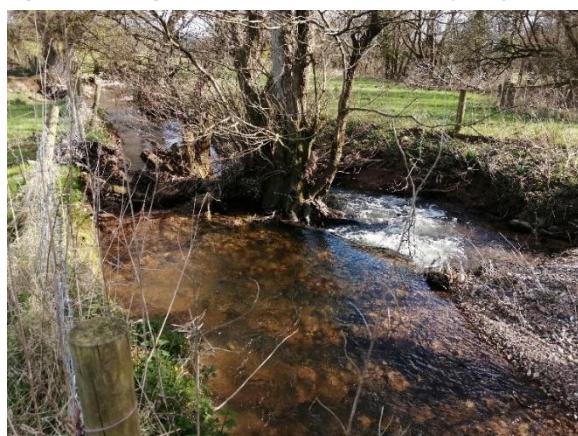
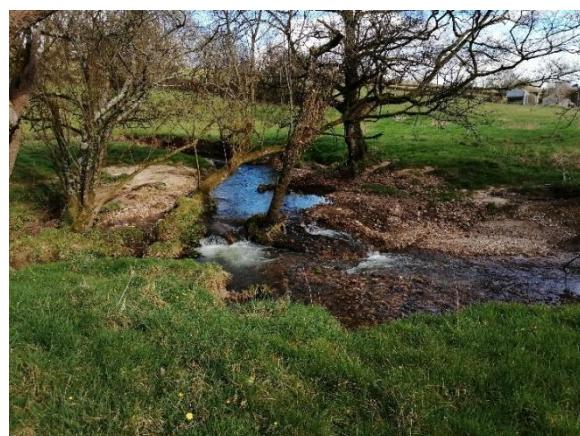
*Figure 48: Developing bypass channel*

A management approach for Higher Westwater Weir is urgently required, since the situation there with the weir being bypassed runs the risk of this location almost completely blocking migratory fish access to the rest of the Yarty, or for major channel incision and instability being triggered for the entire reach upstream – eventually extending to Beckford Bridge.
